DiveMix Ltd.

PASSES INSPECTION - Here is your Visual Plus Inspection Report! Your safety is our first priority, so we have used Visual Plus, the state-of-the art, non-destructive eddy current testing device, as part of your cylinder's visual inspection. Unlike traditional inspections, we do not rely upon the naked eye alone to detect problems in the neck thread area that might affect the integrity of your cylinder - even though such problems are statistically rare. The trace lines record the inspection of the threaded neck region of your cylinder by Visual Plus and indicates that it is in good condition. Remember your cylinder must be inspected visually on a periodic basis according to government established guidelines. For your own protection, experts recommend more frequent inspections if your cylinder is in heavy service or is damaged during use. Ask us!

Customer: ABC DIVERS
Serial Number: P217496
Date: 06/Mrz/2007
Inspected By: Morgan Meinecke
Manufacturer: Catalina
Original Manufacturing Date: 06/Sep/1995
Last Hydro: 06/Mai/2003
Last VISPlus: 06/Mrz/2007
File: EURO DIVERS-P217496-03-06-2007

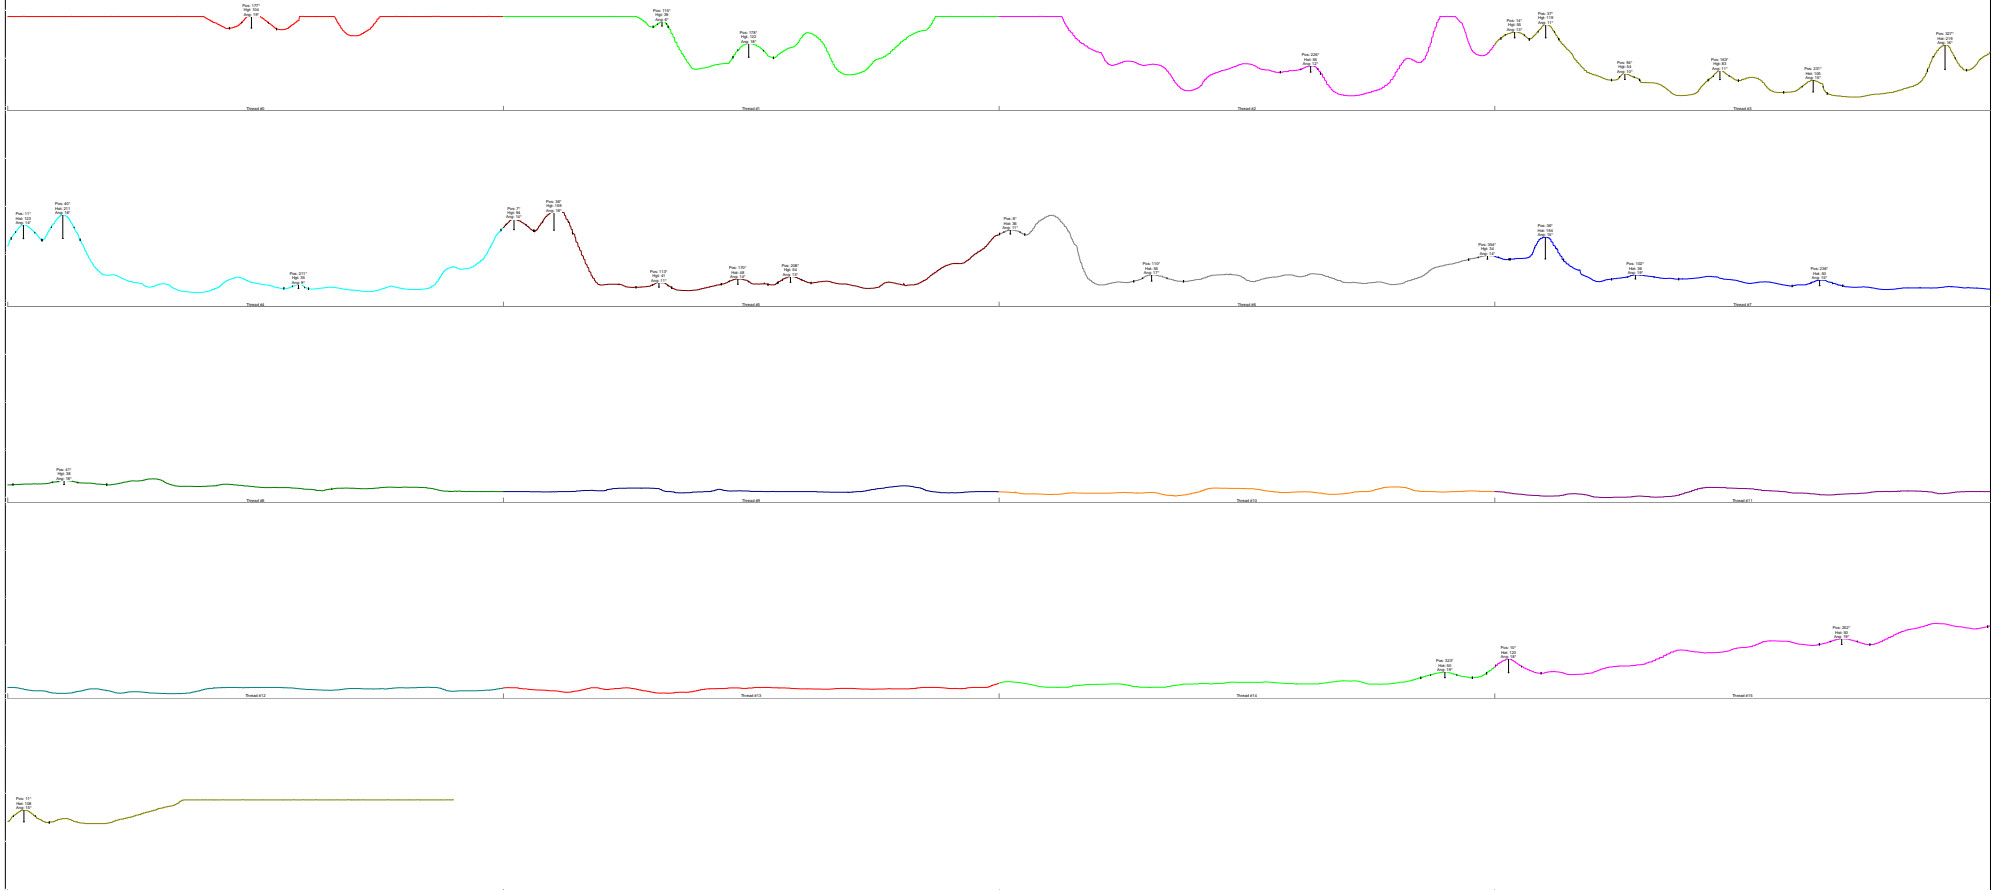
Probe: SCUBA #1; Cal Standard Crack: 11° wide, 115 high, 290 baseline @ 159,78kHz.

Analysis Results: Found 3 cracks in recorded data that are at least 3 threads long.
Please verify analysis accuracy by viewing results and performing visual inspection.
Group of indications at position 10°, height: 77, width: 13°, first thread: 3, last thread: 6
Group of indications at position 37°, height: 163, width: 15°, first thread: 3, last thread: 5
Group of indications at position 108°, height: 44, width: 15°, first thread: 5, last thread: 7
